Errata

MSP430F47173 Microcontroller

ABSTRACT

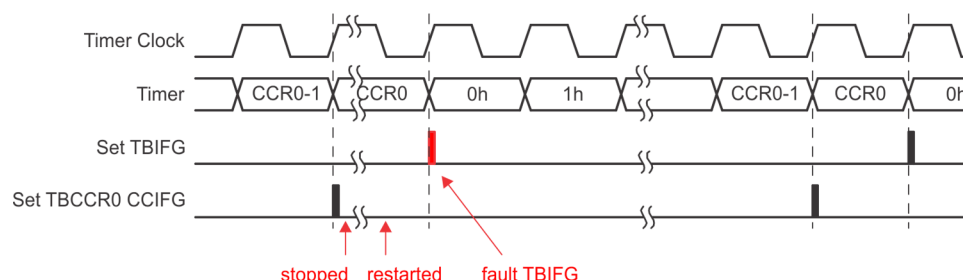
TB24

TBIFG Flag is erroneously set after Timer B restarts in Up Mode

In Up Mode, the TBIFG flag should only be set when the timer resets from TBCCR0 to zero. However, if the Timer B is stopped at $TBR = TBCCR0$, then cleared ($TBR=0$) by setting the TBCLR bit, and finally restarted in Up Mode, the next rising edge of the TBCLK will erroneously set the TBIFG flag.

None.
