Errata

MSP430G2131 Microcontroller

ABSTRACT

This document describes the known exceptions to the functional specifications (advisories).

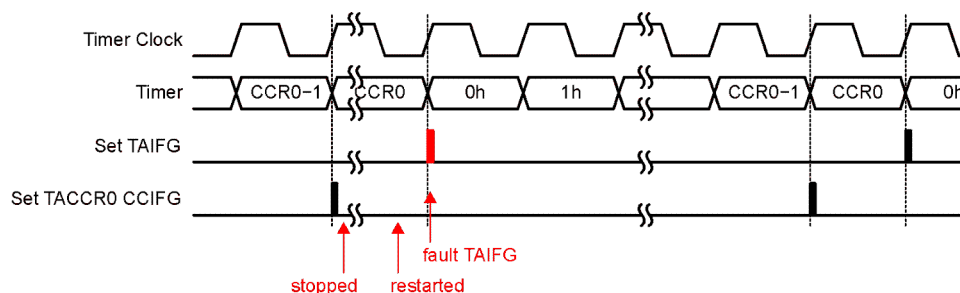
TA21 *TA Module*

Function TAIFG Flag is erroneously set after Timer A restarts in Up Mode

Description In Up Mode, the TAIFG flag should only be set when the timer counts from TACCR0 to zero. However, if the Timer A is stopped at TAR = TACCR0, then cleared (TAR=0) by setting the TACLR bit, and finally restarted in Up Mode, the next rising edge of the TACLK will erroneously set the TAIFG flag.

Workaround None.
