# **AM5K2E04/02**

## **Multicore ARM KeyStone II SOC**

## **Silicon Errata**

Literature Number: SPRZ416B  
May 2014–Revised August 2015

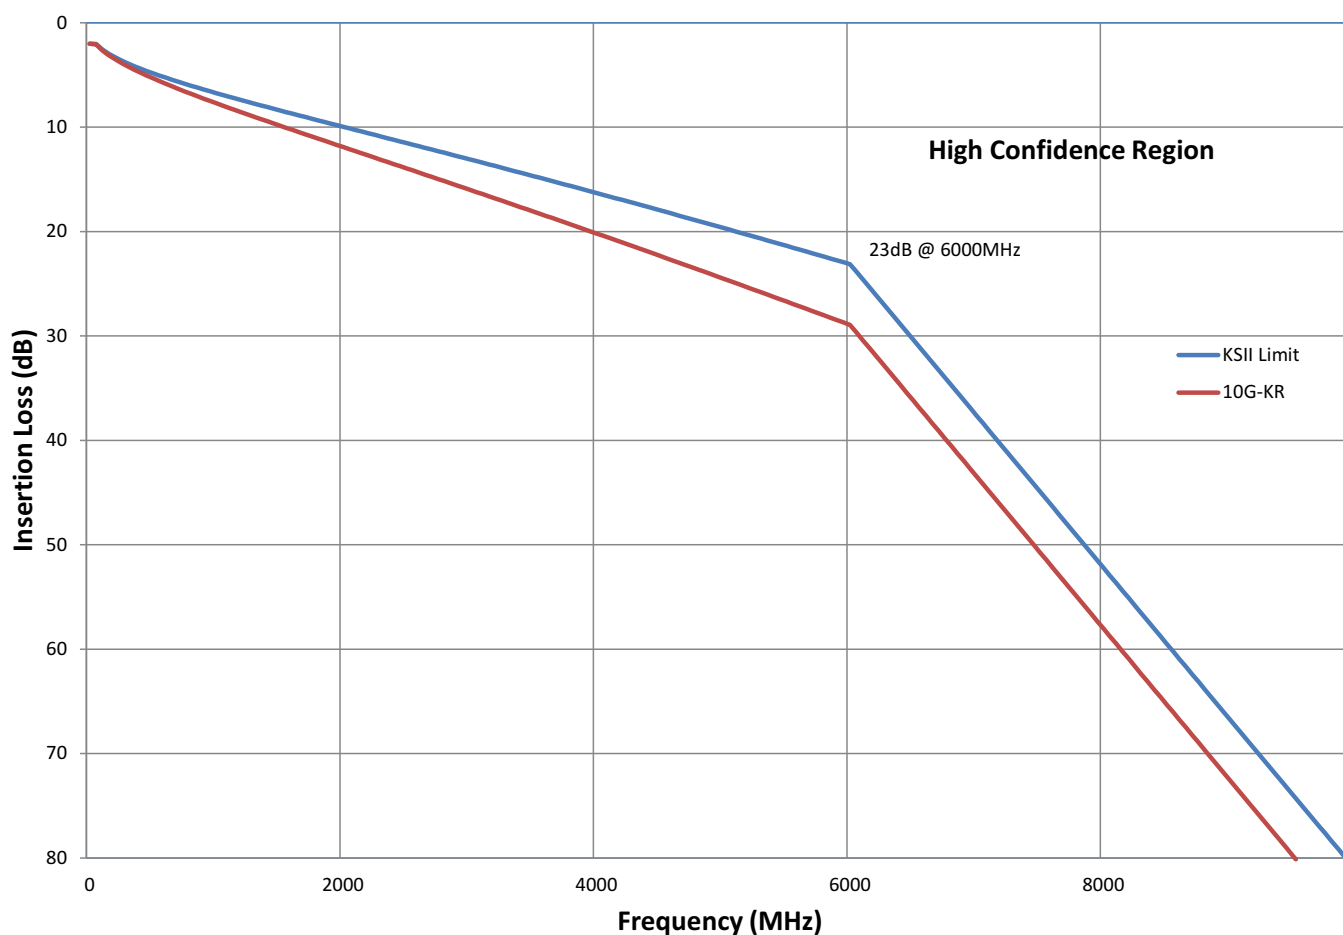
Device characterization has shown that bit error rate performance consistent with the 10GbE-KR standard as published in IEEE 802.3-2008 Annex 69B cannot be met across all device operating extremes. Production devices do operate at the required error rate across all rated operating conditions of voltage and temperature when the channel insertion loss is limited to 20dB at the Nyquist rate of 5.15625GHz. The figure below shows the Insertion Loss template from IEEE 802.3-2008 Annex 69B as well as the reduced Insertion Loss template.

Workaround

None.

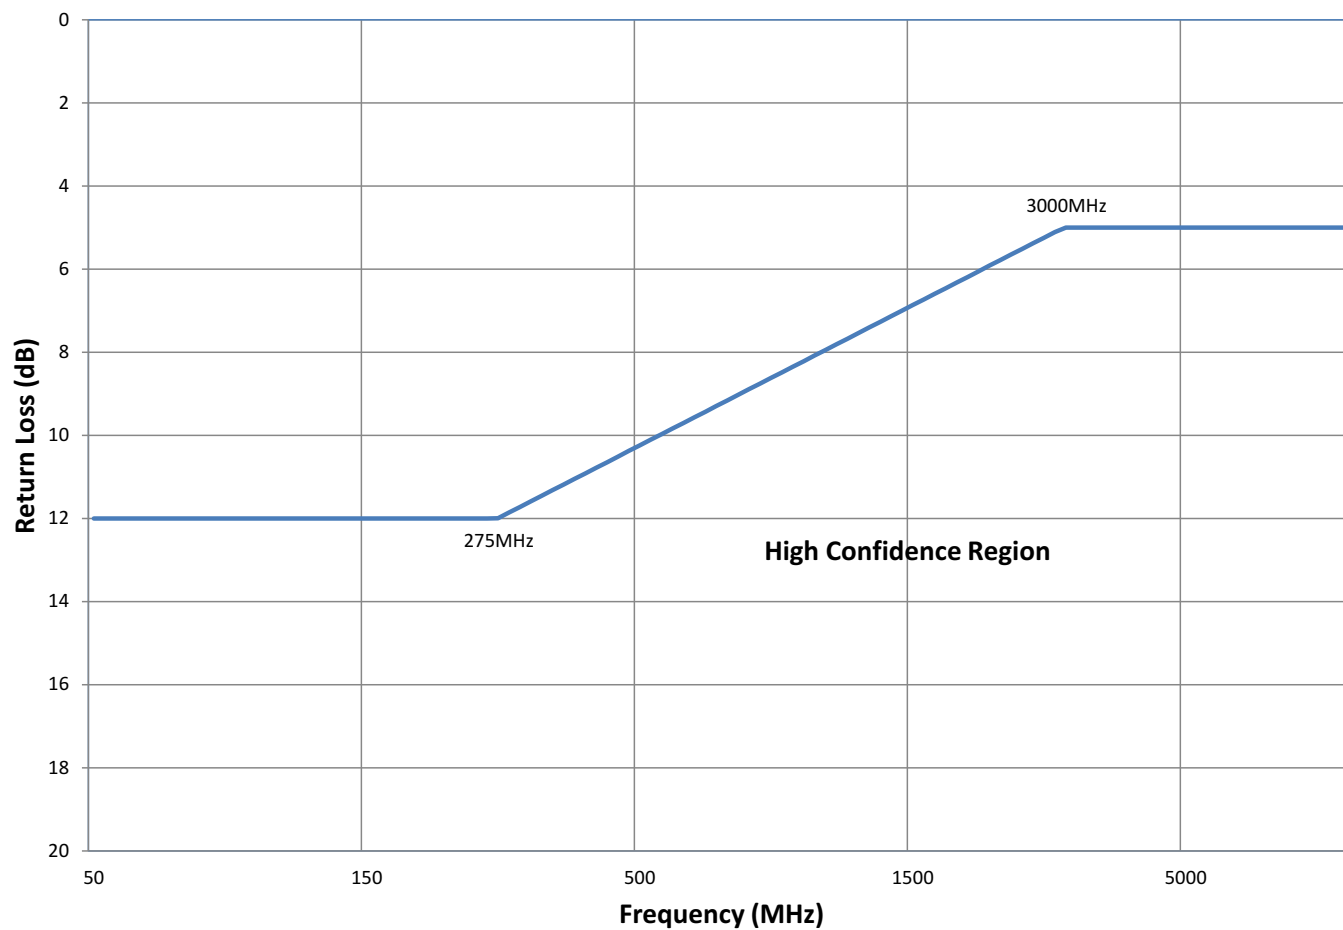
Characterization has shown that channels must also be compliant with the Return Loss template contained in the IEEE 802.3-2008 Annex 69B specification without modification. This is shown below for convenience.

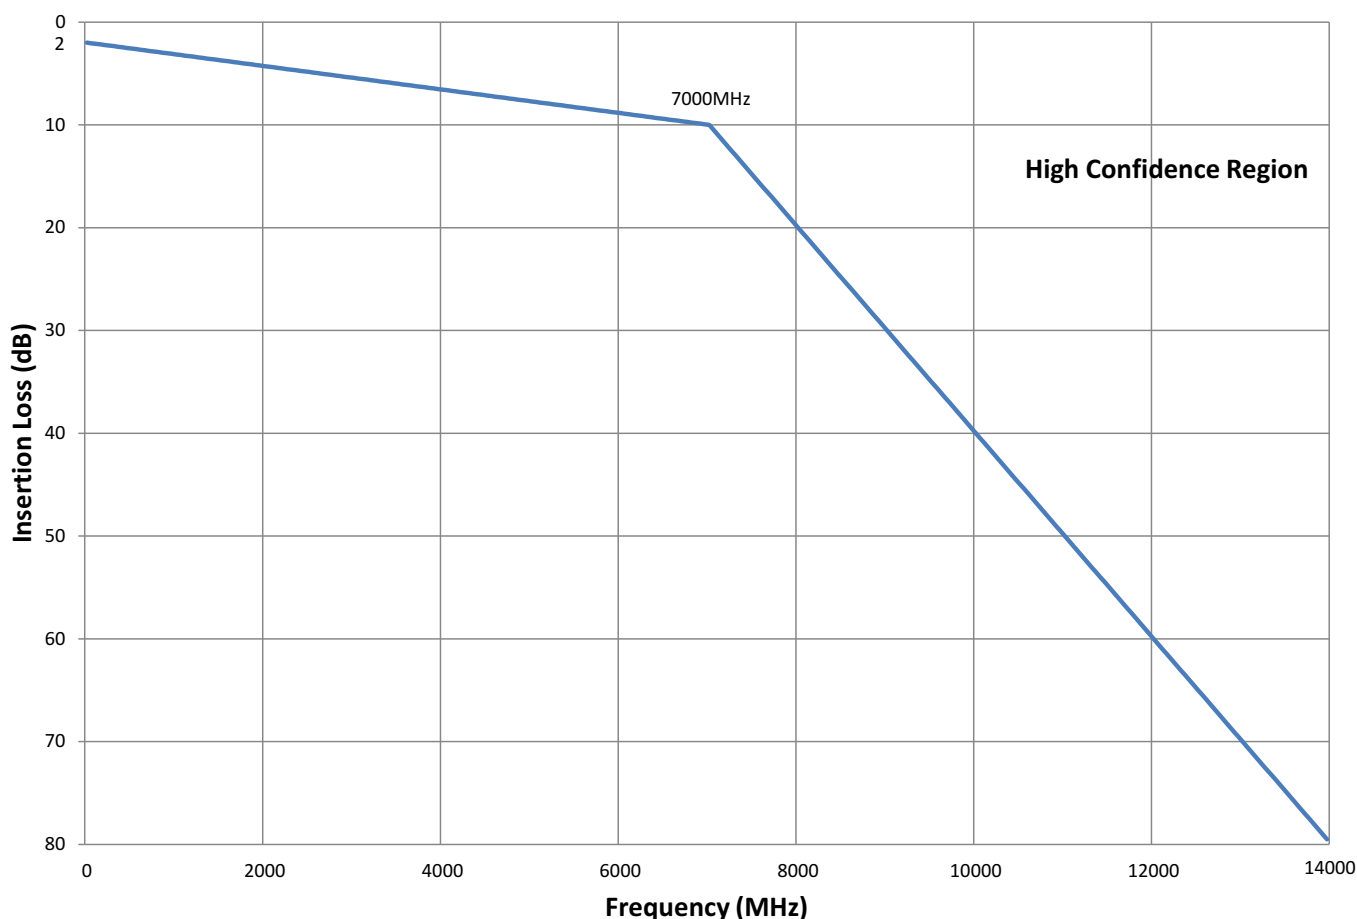
Device characterization has shown that expected bit error rate performance can only be met on layouts that meet constrained channel loss metrics. These can be examined by generating Insertion Loss and Return Loss graphs where loss is plotted versus frequency. Insertion Loss and Return Loss can be estimated during PCB layout using a 3D simulation tool. Insertion Loss and Return Loss should also be measured on early prototypes using a Vector Network Analyzer (VNA). Multiple PCB construction and layout enhancement techniques must be combined to achieve these channel performance requirements as stated in the KeyStone II SERDES User Guide.

An Insertion Loss measurement provides a composite view of the channel's loss versus frequency. Since HyperLink is a short-reach interface, channel loss is limited. Also, due to the high data rate, the Insertion Loss must be monotonic and without discontinuities that would degrade receiver operation. The template shown below provides Insertion Loss limits that will result in a robust channel. This template must be met for the entire channel from transmitter to receiver including the series capacitors.

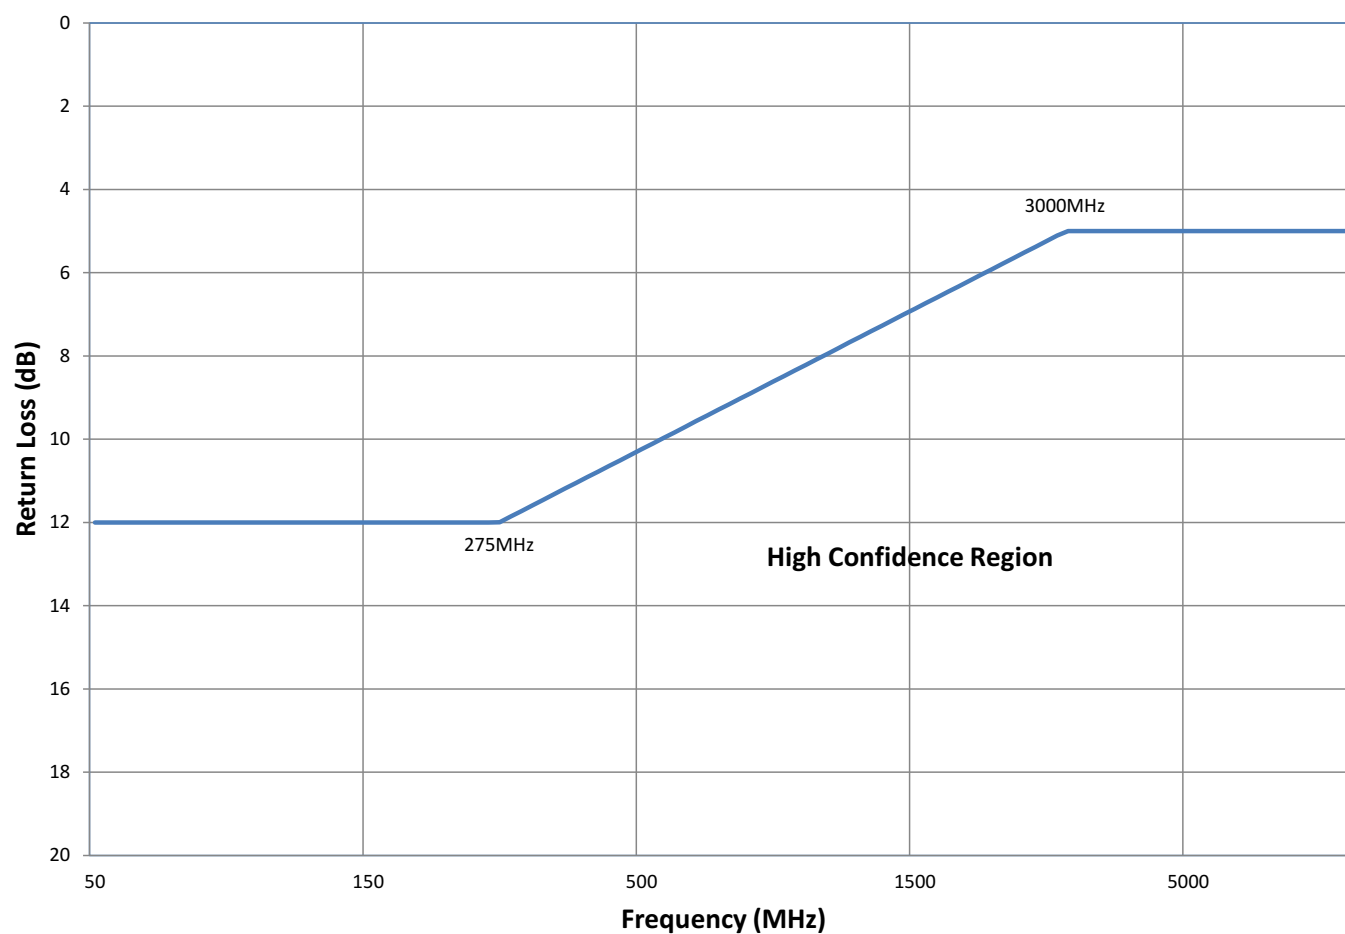
Device characterization has also shown that channels should be compliant with the Return Loss template shown below. The Return Loss measurement indicates the amount of energy reflected back to the source which is not available to the receiver. Impedance variation in the channel will cause reflected energy that can cause this template to be violated. Careful attention to PCB construction and layout must be followed to meet this requirement. This template must be met for the entire channel from transmitter to receiver including the series capacitors. Note that this is the same template

defined in IEEE 802.3-2008 Annex 69B specification for 10GbE.

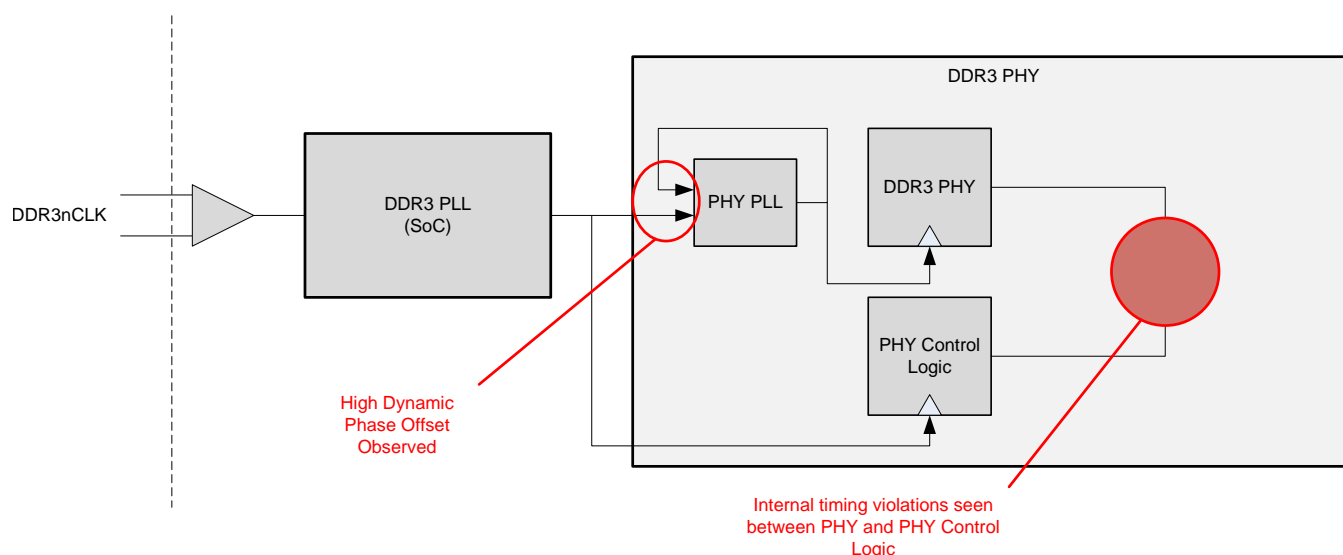
Figure 2. DDR3 PHY

DDR3 read operations may show errors due to increased levels of Dynamic Phase Offset (DPO) inside the DDR3 PHY. These errors are characterized by byte lane data corruption or intermittent bit errors. The byte lane data corruption can only be recovered using a device reset.

The DDR3 clocking architecture is illustrated in the figure below. The DDR3 reference clock input (DDR3nCLK) feeds the DDR3 SoC PLL, which outputs a clock to be used by the PHY Control Logic and provide an input to the PHY PLL.

The Dynamic Phase Offset (DPO) is a measure of the DDR3 PHY PLL's ability to track rapid phase changes in the output of the DDR3 SoC PLL. High DPO can create internal timing violations between the DDR3 PHY and DDR3 PHY Control Logic and result in data errors during reads. As indicated by the shaded red circle in the figure above, the timing violations occur in the data transfer between the PHY and PHY control logic. It was determined that the root cause of the elevated DPO were SoC PLL and PHY PLL configurations that were non-optimized for the timing requirements of the system.

The workaround for this behavior is a change in the PLL configurations used for the DDR3 SoC PLL and the DDR3 PHY PLL. New configurations have been generated for DDR3-1600, DDR3-1333, DDR3-1066, and DDR3-800 operation and are presented in the tables below. Per field alert, "DDR3 Limited to Highest Data Rates Due to Possibility of PLL Instability During Temperature Changes after Startup", operation of DDR3-1066 and/or DDR3-800 is not recommended for affected Keystone2 devices in production systems

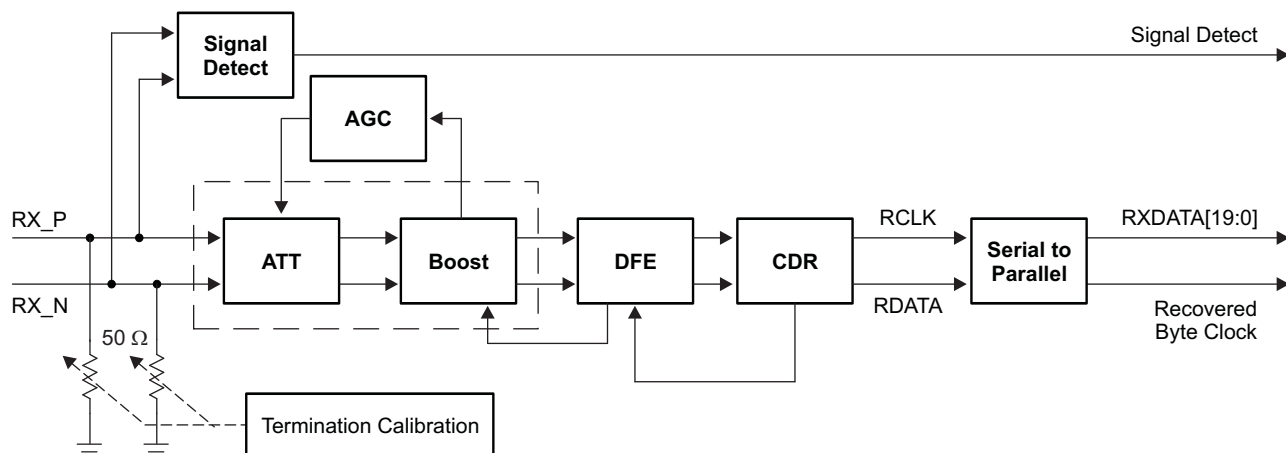
**Figure 3. RX Path Block Diagram**

**Details** The TI SerDes contains an adaptation algorithm that allows the RX equalization blocks to adapt their parameters to the SerDes data channel. The adaptation algorithm sets the optimal values for the ATT, BOOST, and DFE blocks in order to equalize the signal, maximize margin, and minimize channel distortion. For higher data rates (i.e. 5Gbps and greater), the high frequency gain provided by the BOOST block is generally considered necessary to compensate for the low-pass characteristics of data channels and widen the data eye.

The SerDes BOOST block was designed to require a specific set of patterns in order to best adapt its parameters to the channel. If these patterns are not found, the BOOST adaptation algorithm will not update the internal block settings and/or may incorrectly update these settings. The required data pattern is a series of six 0's followed by a 101 pattern. This pattern must occur numerous times on both odd and even bit alignments. This data pattern is not present in the 8b/10b coded symbols that are sent over many of the high speed peripheral links.

The recommended workaround is to not use the RX equalization auto-adaptation mechanism with the impacted interfaces at higher data rates. As an alternative, a user can hardcode the optimal ATT and BOOST values for their channel.

The optimal ATT and BOOST values found by one of the two above methods can be hardcoded into the SerDes upon initialization.
