66AK2Lxx
Multicore DSP+ARM KeyStone II SOC
Silicon Revision 1.0

Silicon Errata

Literature Number: SPRZ430

April 2015

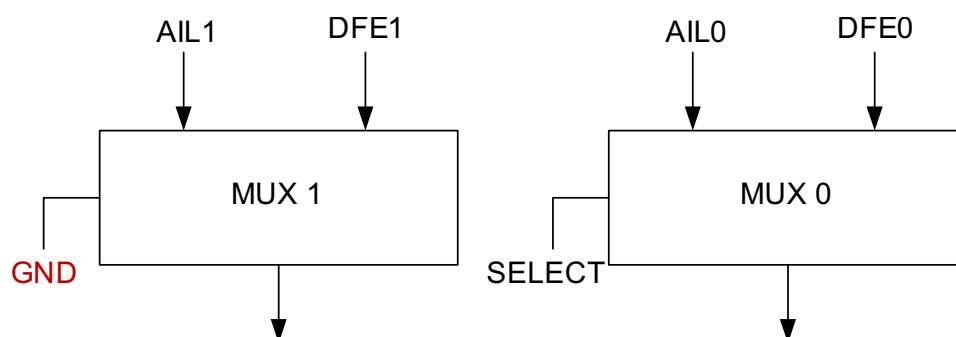
Figure 2. AIL Lanes

IQN2 MUX Works Only with AIL0 and Not With AIL1

IQN2 has two AIL lanes (AIL0 and AIL1). AIL1 lane does not transmit or receive any data. AIL0 lane can transmit or receive data without showing any problem.

As shown in [Figure 2](#) below, the AIL0 and AIL1 lanes are connected to a SERDES MUX with respect DFE lanes. This SERDES MUX is used to select data path between IQN2 and DFE. The mux select for the AIL1 and DFE1 mux is not connected correctly and is connected to Ground. So DFE1 lane is always selected irrespective of the configuration selected by mux pins.

There is no SW workaround for this problem.
